# Manhole Inspection Summary

Manhole # S41C\_\_001MH

Insp Date: **10/2/08 11:16 AM**

**Location** Address: **orleans st**

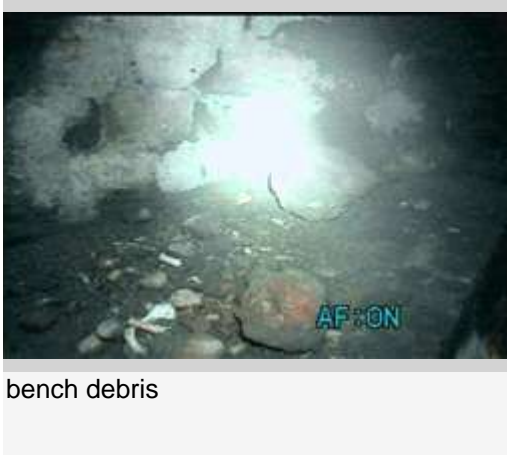
Defect 3

Condition: ☐ Sound ☐ Cracked ☐ Root Intrusion ☐ Deteriorated ☐ Leaks ☒ **Debris**

bench debris

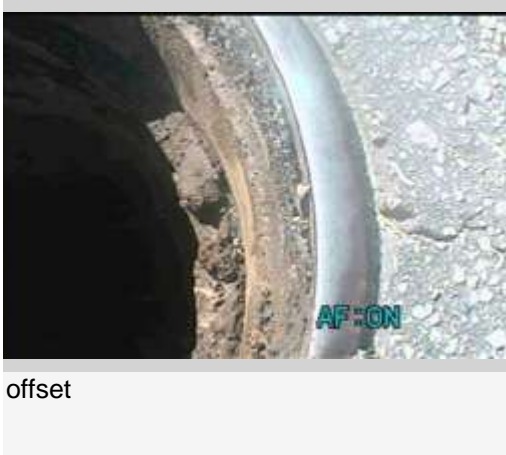
Defect 2

Offset: **2** (in.)

offset

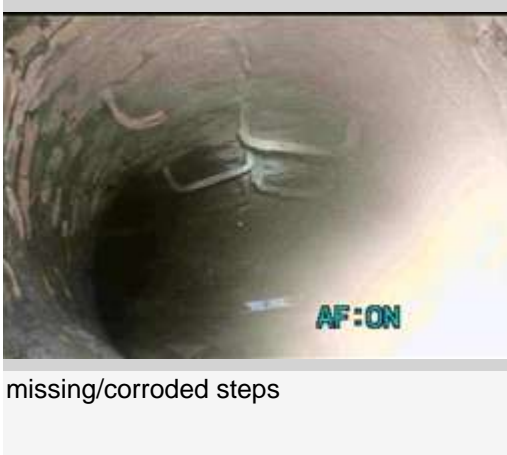
Defect 1

Count: **5** Missing: **1** ☒ **Corroded**

missing/corroded steps

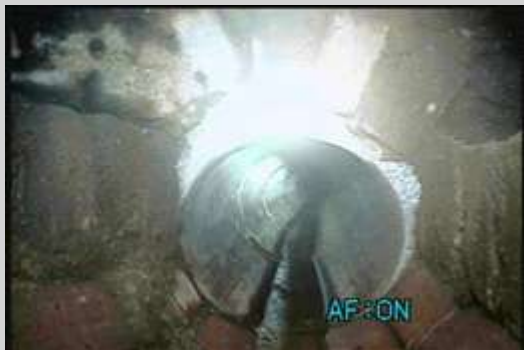
12 O'Clock Outflow

8 in. Circular Gravity Sewer  
Pipe Out @ 12 O'Clock

Invert Depth: **10.20** (ft.) Flow Characteristics: **Slow**

Infiltration: **None** Pipe Seal Cond: **Unknown**

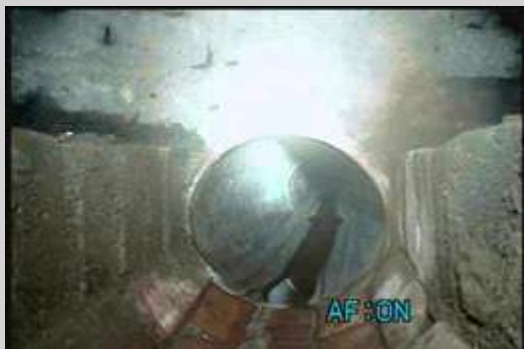
6 O'Clock Inflow

8 in. Circular Gravity Sewer  
Pipe In @ 6 O'Clock

Invert Depth: **10.16** (ft.) Flow Characteristics: **Slow**

Infiltration: **None** Pipe Seal Cond: **Unknown**

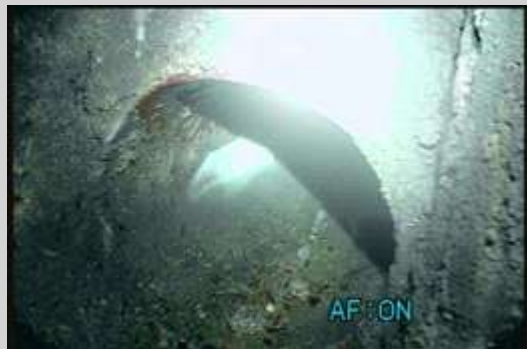
9 O'Clock Inflow

8 in. Circular Gravity Sewer  
Pipe In @ 9 O'Clock

couldnt get better pic. pipe on an angle

Connects To: House connection / Service line
